# **LAKE CLASSIFICATION REPORT FOR PATRICK LAKE, ADAMS COUNTY**

**Presented by Reesa Evans, CLM, Lake Specialist  
Adams County Land & Water Conservation Department  
P.O. Box 287, Friendship, WI 53934**

**NOVEMBER 2008**

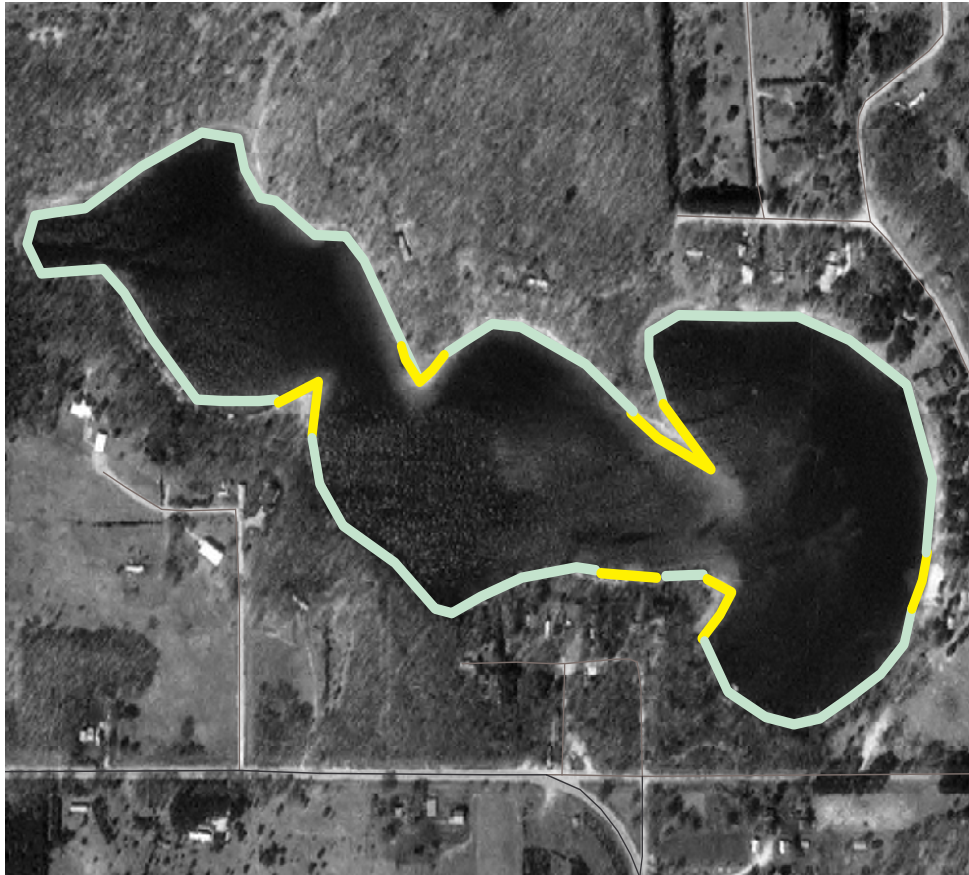
**Figure 9: Shoreland Map of Patrick Lake (2004)**

A 2004 shore survey showed that most of the shore had an “adequate buffer.” An “adequate buffer” is a native vegetation strip at least 35 feet landward from the shore. However, there were still areas of “inadequate” buffers, mostly those with mowed lawns and insufficient native vegetation at the shoreline to cover 35 feet landward from the water line. There are also several areas of sand bars and some active erosion.

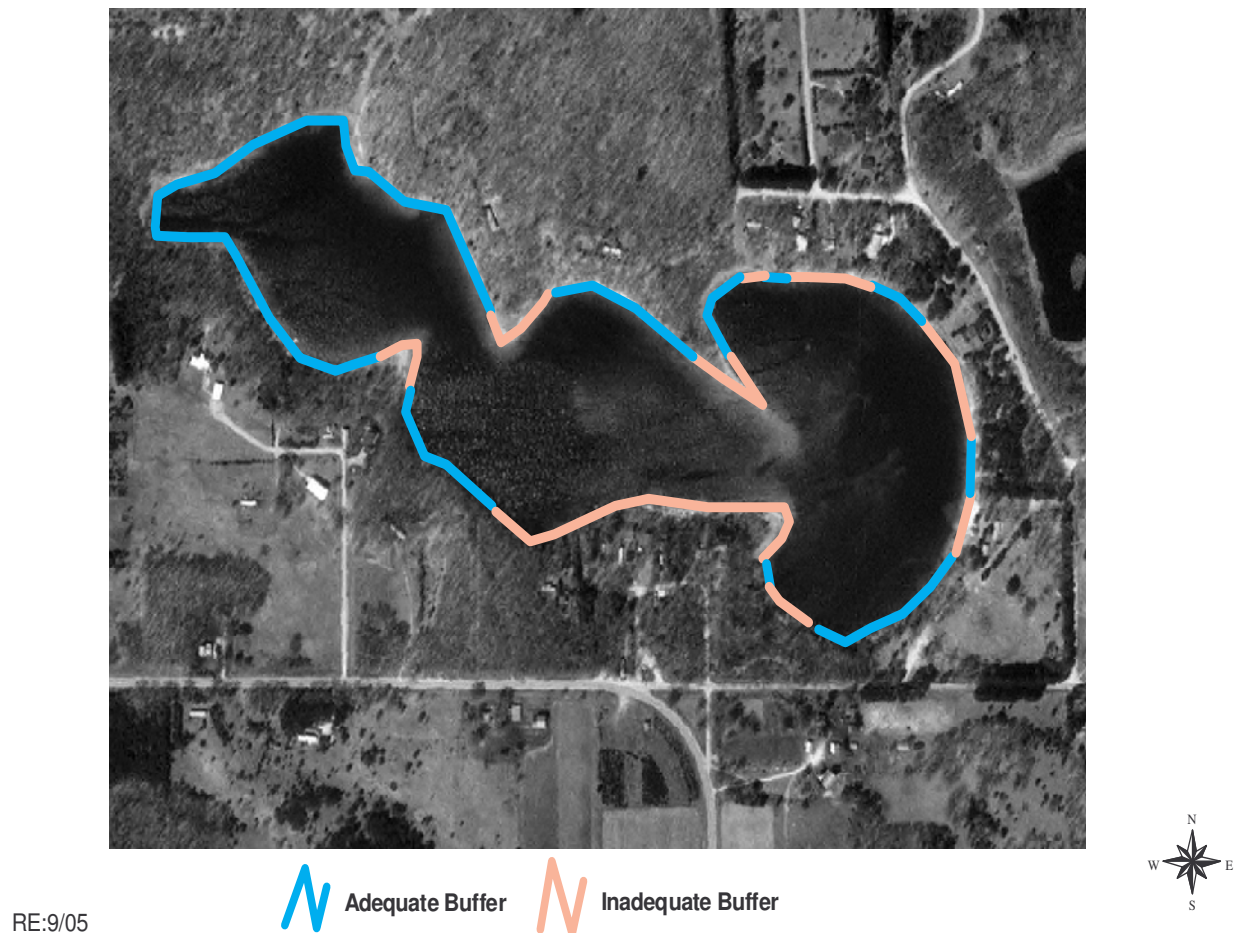
**Figure 12: Patrick Lake Buffer Map (2004)**

A 2004 shore survey showed that most of the shore had an "adequate buffer." An "adequate buffer" is a native vegetation strip at least 35 feet landward from the shore. However, there were still areas of "inadequate" buffers, mostly those with mowed lawns and insufficient native vegetation at the shoreline to cover 35 feet landward from the water line. There are also several areas of sand bars and some active erosion.

Vegetated shoreland buffers help stabilize shoreline banks, thus reducing bank erosion. The plant roots give structure to the bank and also increase water infiltration and decrease runoff. A vegetated shore is especially important when shores are steep and soft, as are some of Patrick Lake shores. Figure 12 maps the adequate and inadequate buffers on Patrick Lake.

Adequate buffers on Patrick Lake in some places could be easily installed on the inadequate areas by either letting the first 35 feet landward from the water just grow without mowing it, except for a path to the water, or by planting native seedlings sufficient to fill in the first 35 feet or using biologists to protect the shore that are vegetated. Where areas are deeply eroded, shaping, revegetating and protecting the shores will be necessary to prevent further erosion.

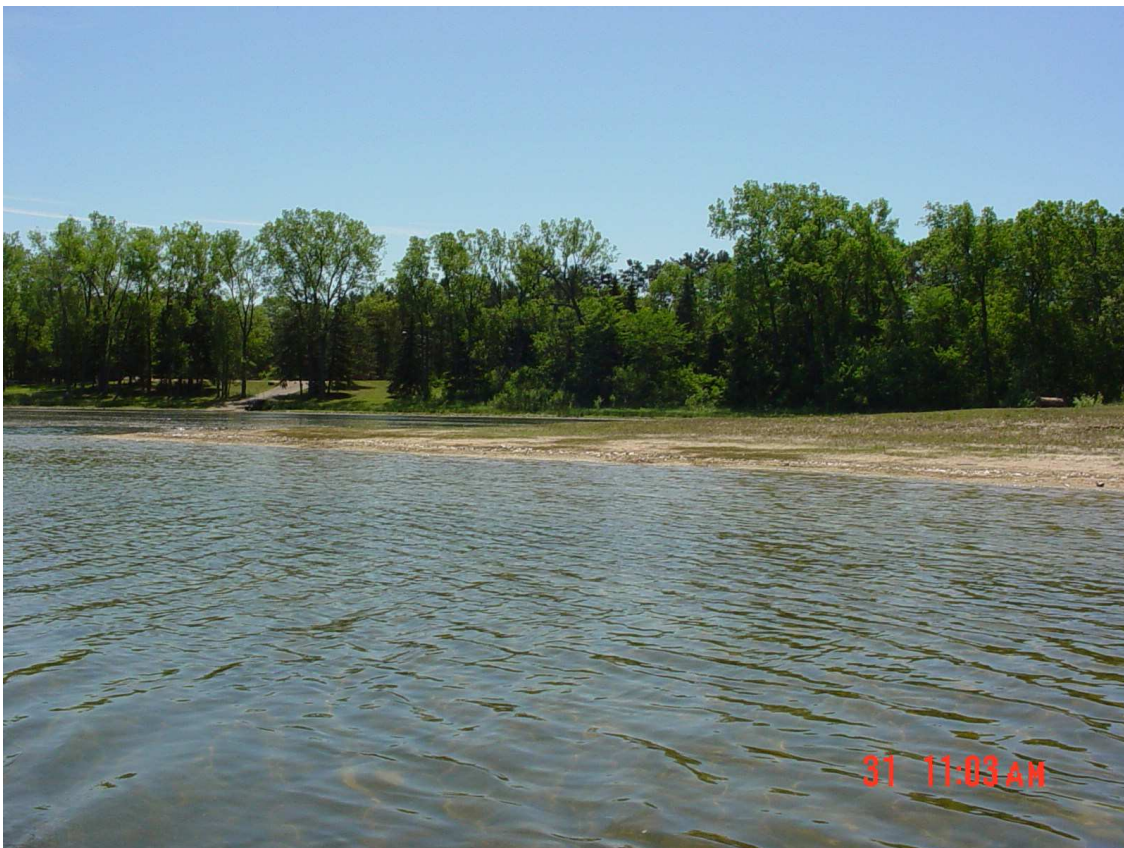
**Figure 50: Photo Showing Area PA1**

Area PA1 extends along approximately 800 feet of the shoreline. 70% of the shore is native herbaceous vegetation; 23.3% of the shore is cultivated lawn; the remaining shore is hard structure. There are downed logs in the water that provide fish and wildlife cover. Filamentous algae were found in this area. There is a moderate level of human disturbance at this area. No threatened or endangered species were found here. Aquatic vegetation at this site included 1 emergent species, 2 species of floating-leaf rooted plants and 7 species of submergent aquatic plants. Curly-Leaf Pondweed, an exotic invasive plant, was found in this area. Most of the aquatic vegetation in this area has multiple uses for fish and wildlife. Because this site provides all three structural types of vegetation, the community has a diversity of structure and species that supports even more diversity of fish and wildlife.

Maximum rooting depth of aquatic vegetation in PA1 was 5.5 feet. No threatened or endangered species were found here. Bulrush, an emergent plant, is found in this area. Emergents provide important fish habitat and spawning areas, as well as food and cover for wildlife. Aquatic vegetation at this site included 2 species of floating-leaf rooted plants and 7 species of submergent aquatic plants. A diverse submergent community provides many benefits. Curly-Leaf Pondweed, an exotic invasive plant, was found in this area. Most of the aquatic vegetation in this area has multiple uses for fish and wildlife. Because this site provides all three structural types of vegetation, the community has a diversity of structure and species that supports even more diversity of fish and wildlife.

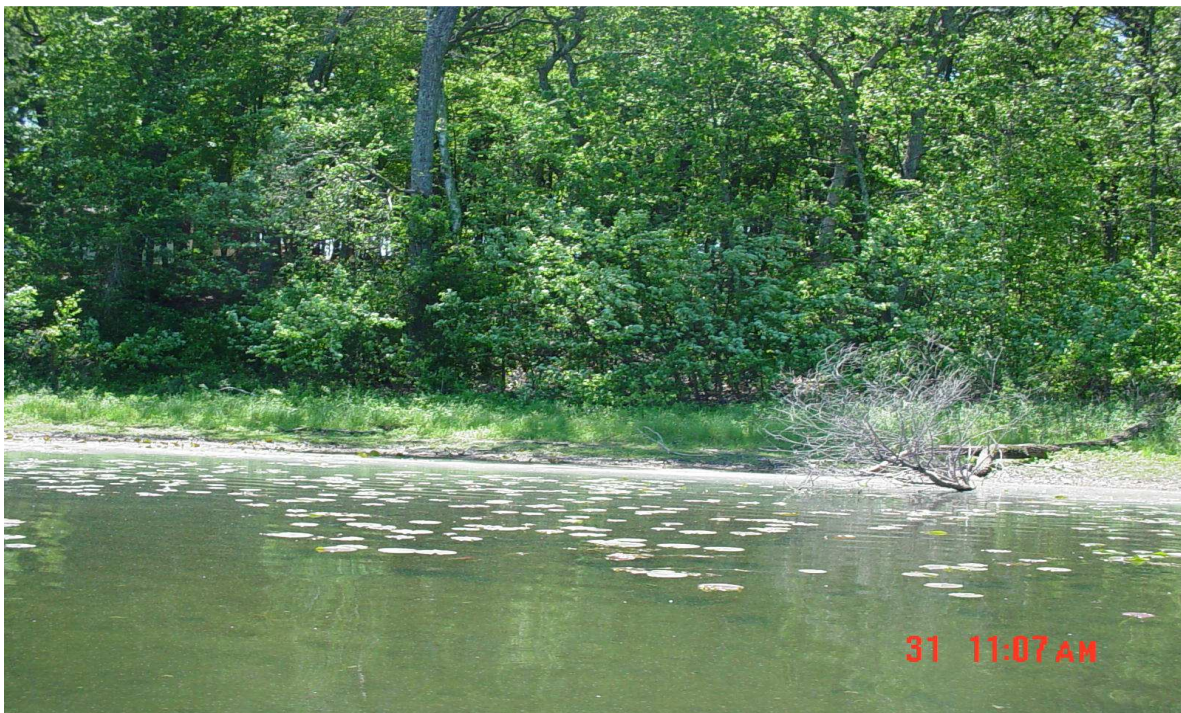
**Figure 51: Photo of Part of PA2**

Area PA2 extends along approximately 1000 feet of the shoreline. 25% of the shore is wooded; 10% has shrubs; 45% is native herbaceous cover. The remaining shore is cultivated lawn and hard structure. Large woody cover is common in the shallow water for habitat. Maximum rooting depth in CR2 was 13 feet. No threatened or endangered species were found in this area. One exotic invasive, *Potamogeton crispus* (Curly-Leaf Pondweed), was found in this area. *Myriophyllum spicatum* had been found previously here. Most of the area had filamentous algae, especially near the shores. The plant-like algae, *Chara* spp was abundant in this area. There is a shortage of emergent plants in this area. One floating-leaf rooted plant species was found. The remaining 6 aquatic plant species were all submergents.

Maximum rooting depth in CR2 was 13 feet. No threatened or endangered species were found in this area. One exotic invasive, *Potamogeton crispus* (Curly-Leaf Pondweed), was found in this area. *Myriophyllum spicatum* had been found previously here. Most of the area had filamentous algae, especially near the shores. The plant-like algae, *Chara* spp was abundant in this area. There is a shortage of emergent plants in this area, which is unfortunate, since emergents provide important fish habitat and spawning areas, as well as food and cover for wildlife. One floating-leaf rooted plant species was found. The remaining 6 aquatic plant species were all submergents.

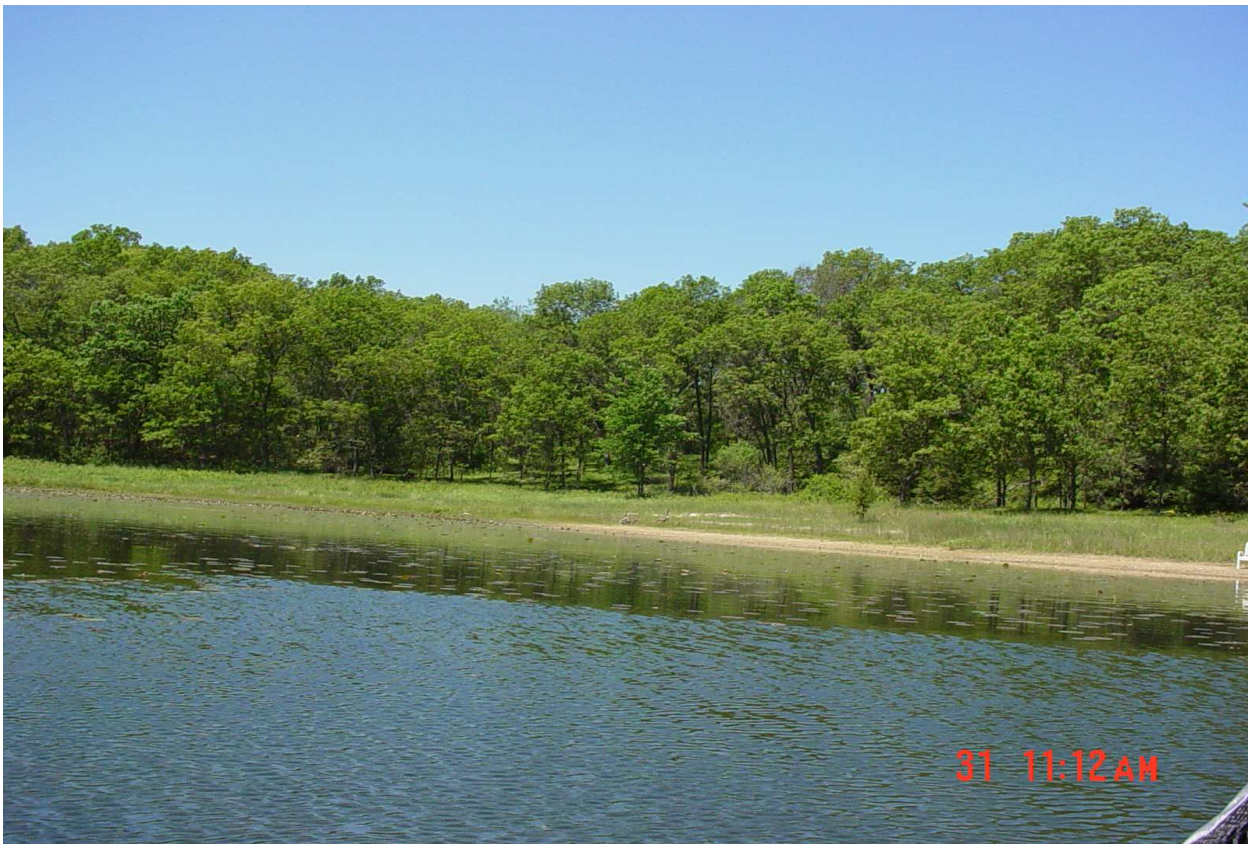
**Figure 52: Photo of Part of PA3**

Area PA3 extends along approximately 1650 feet of the shoreline. Sediment includes marl, muck, peat, sand, silt and mixtures thereof. 6.7% of the shore is wooded; 5% has shrubs; 85% is native herbaceous cover—the remaining is cultivated lawn. Large woody cover is present in shallow water for fish and wildlife cover. Scenic beauty in part of the area is lessened due to the human development. Maximum rooting depth in PA3 was 7 feet. No threatened or endangered species were found in this area. *Chara* spp and filamentous algae were present in area PA3. Only one emergent species found in this area. One floating-leaf rooted plant was present here. 5 species of submergent aquatic species were found here. *Potamogeton crispus* was common here. Another exotic invasive, *Myriophyllum spicatum* (Eurasian watermilfoil), was previously found in this area.

Many of these plants are used by wildlife and fish for multiple purposes. Because this site provides all three structural types of vegetation, the community has a diversity of structure and species that supports even more diversity of fish and wildlife.
